Summary of EPA Surface Water Sampling Results to Date

Gold King Mine Blowout

Updated August 7, 2015

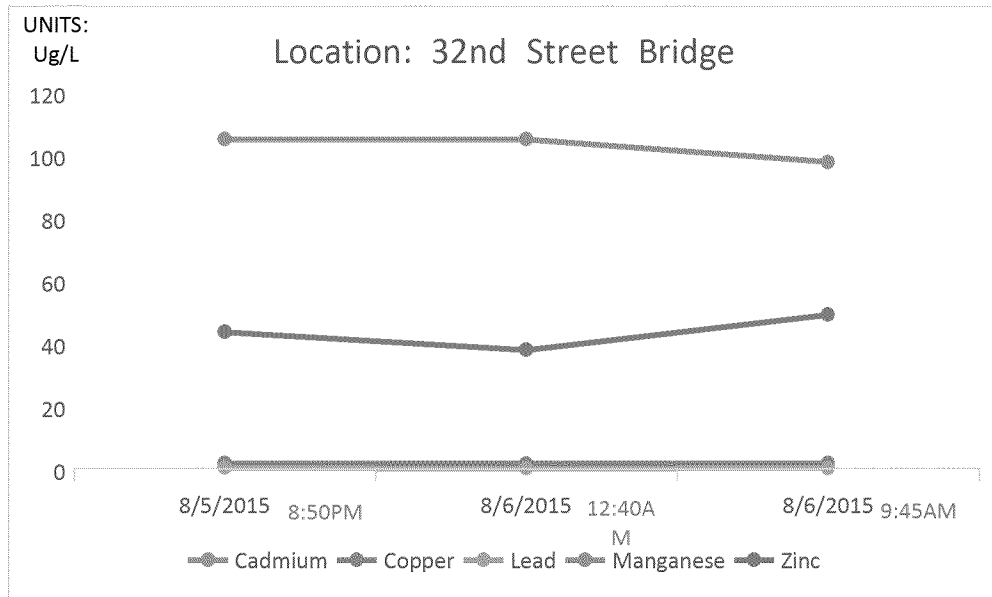
The fifth graph is of the 32nd Street Bridge sampling location. At the time the samples were collected, it does not appear that the contamination had yet reached this sampling location. It is believed that subsequent data collection activities will demonstrate an increase in metals concentrations followed by a decrease to baseline.
